Manhole Inspection Summary

Manhole # S25Q__007MH

Insp Date: **4/8/08 2:39 PM**

Location Address: **15 W.HAMBURG ST.**

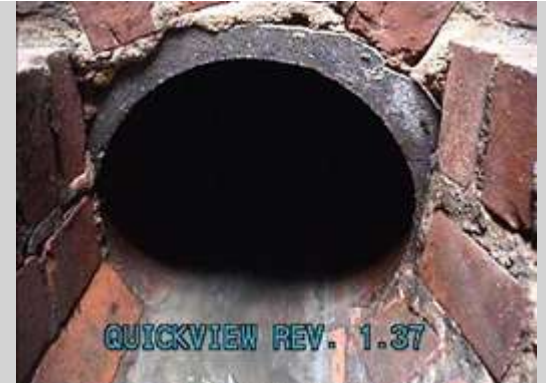
12 O'Clock Outflow

10 in. Circular Gravity Sewer
Pipe Out @ 12 O'Clock

Pipe Height: **10.8** (in.) Rod and Bar (Angled)
Pipe Material: **Clay** ☐ Pipe Lined
Invert Depth: **7.82** (ft.) Flow Characteristics: **Slow**
Deposits: ☒ None ☐ Mud ☐ Sludge ☐ Debris ☐ Grease
Silt Depth: **0** (in.) Deposits Extent:
Infiltration: **None** Pipe Seal Cond: **Sound**
